2018 AASHTO SCOBS Bridge Meeting T-1 Bridge Security & Hazards

Case Studies Rehabilitation from extreme events

Artur D'Andrea

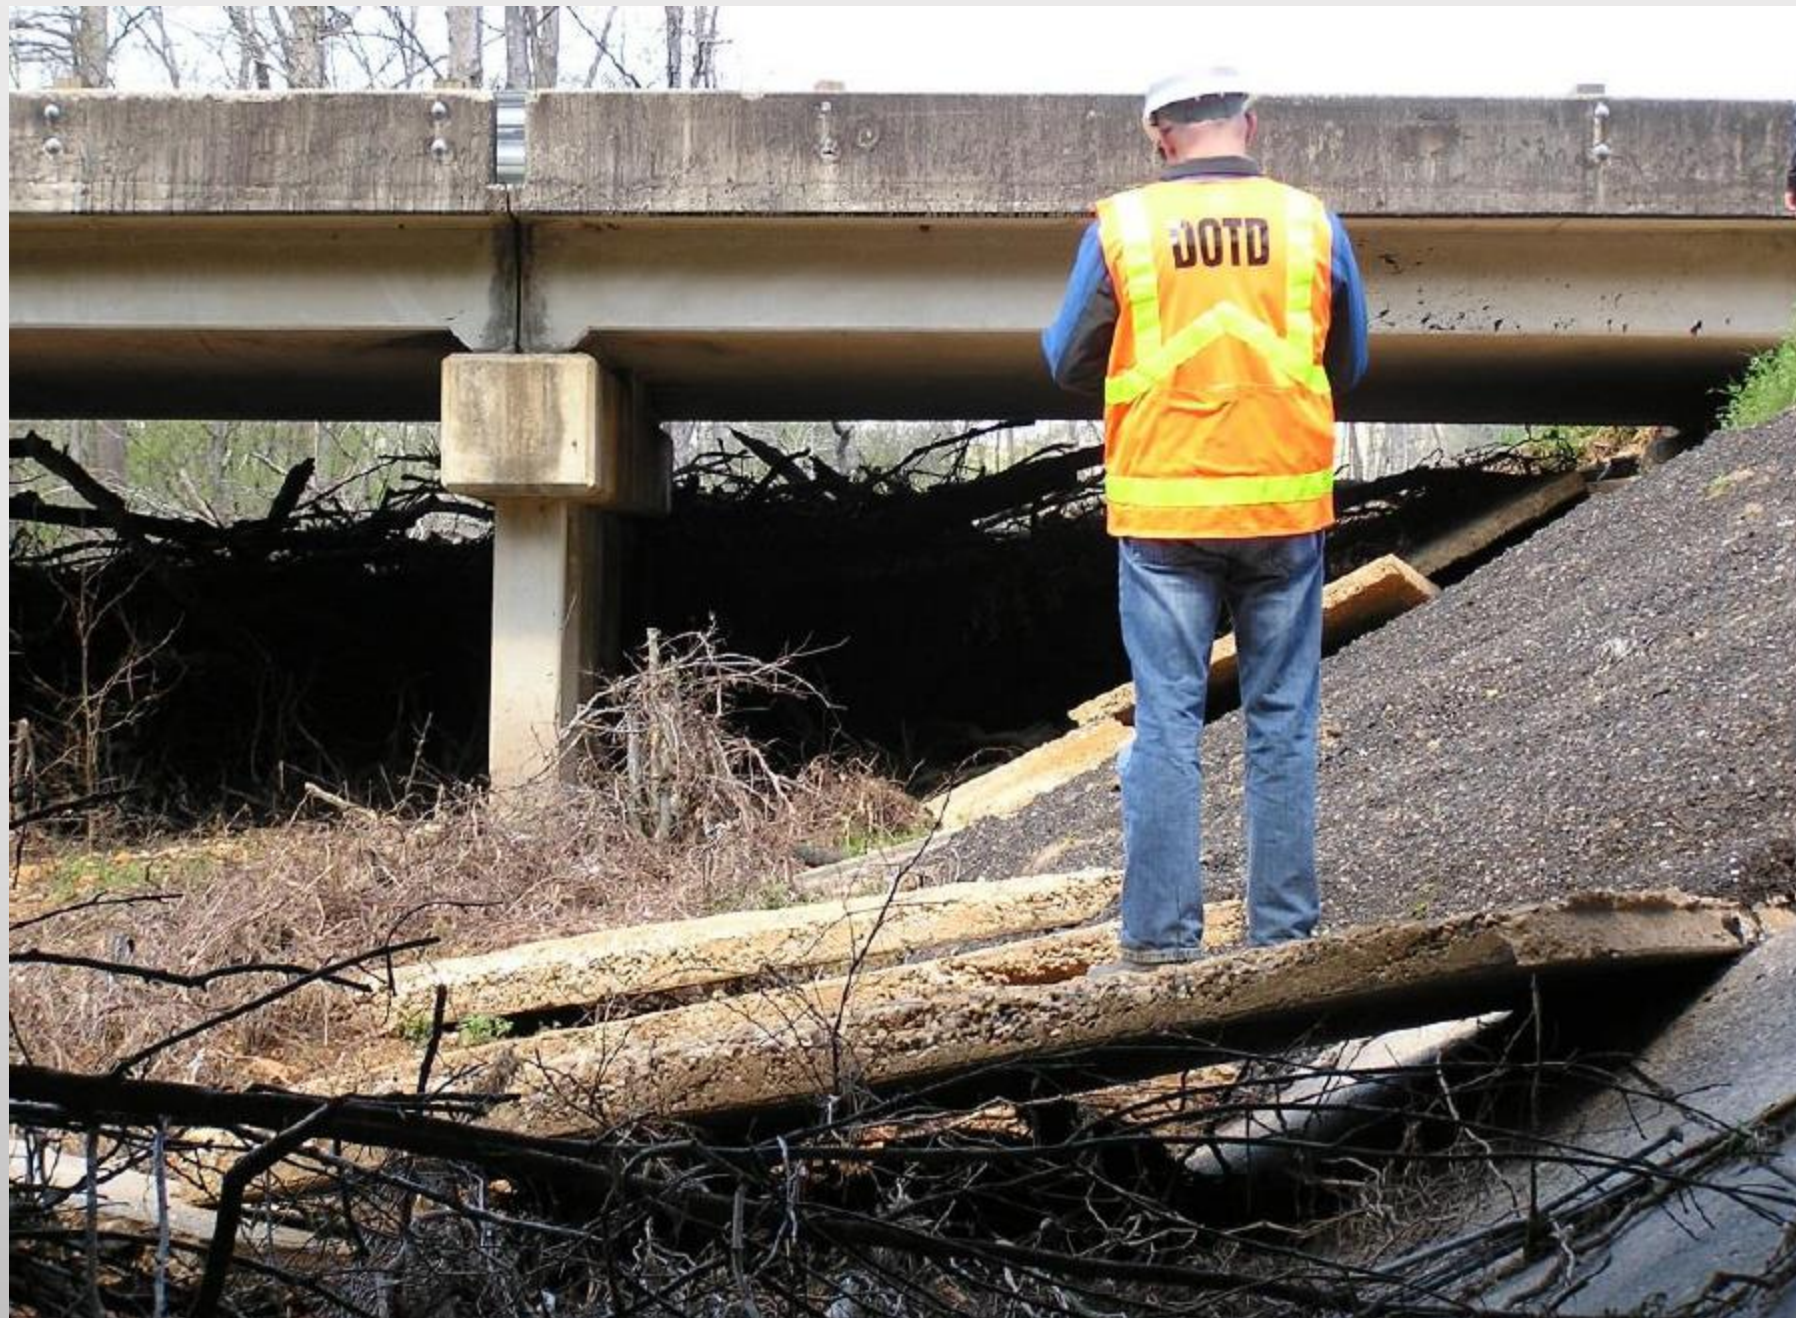
Drift accumulation on northwest corner of bridge. Bridges are adjacent to recent clear cut. Cast-in-place revetment failure and wash out on east end between eastbound and westbound bridges ~ approximately 100 ft x 25 ft.

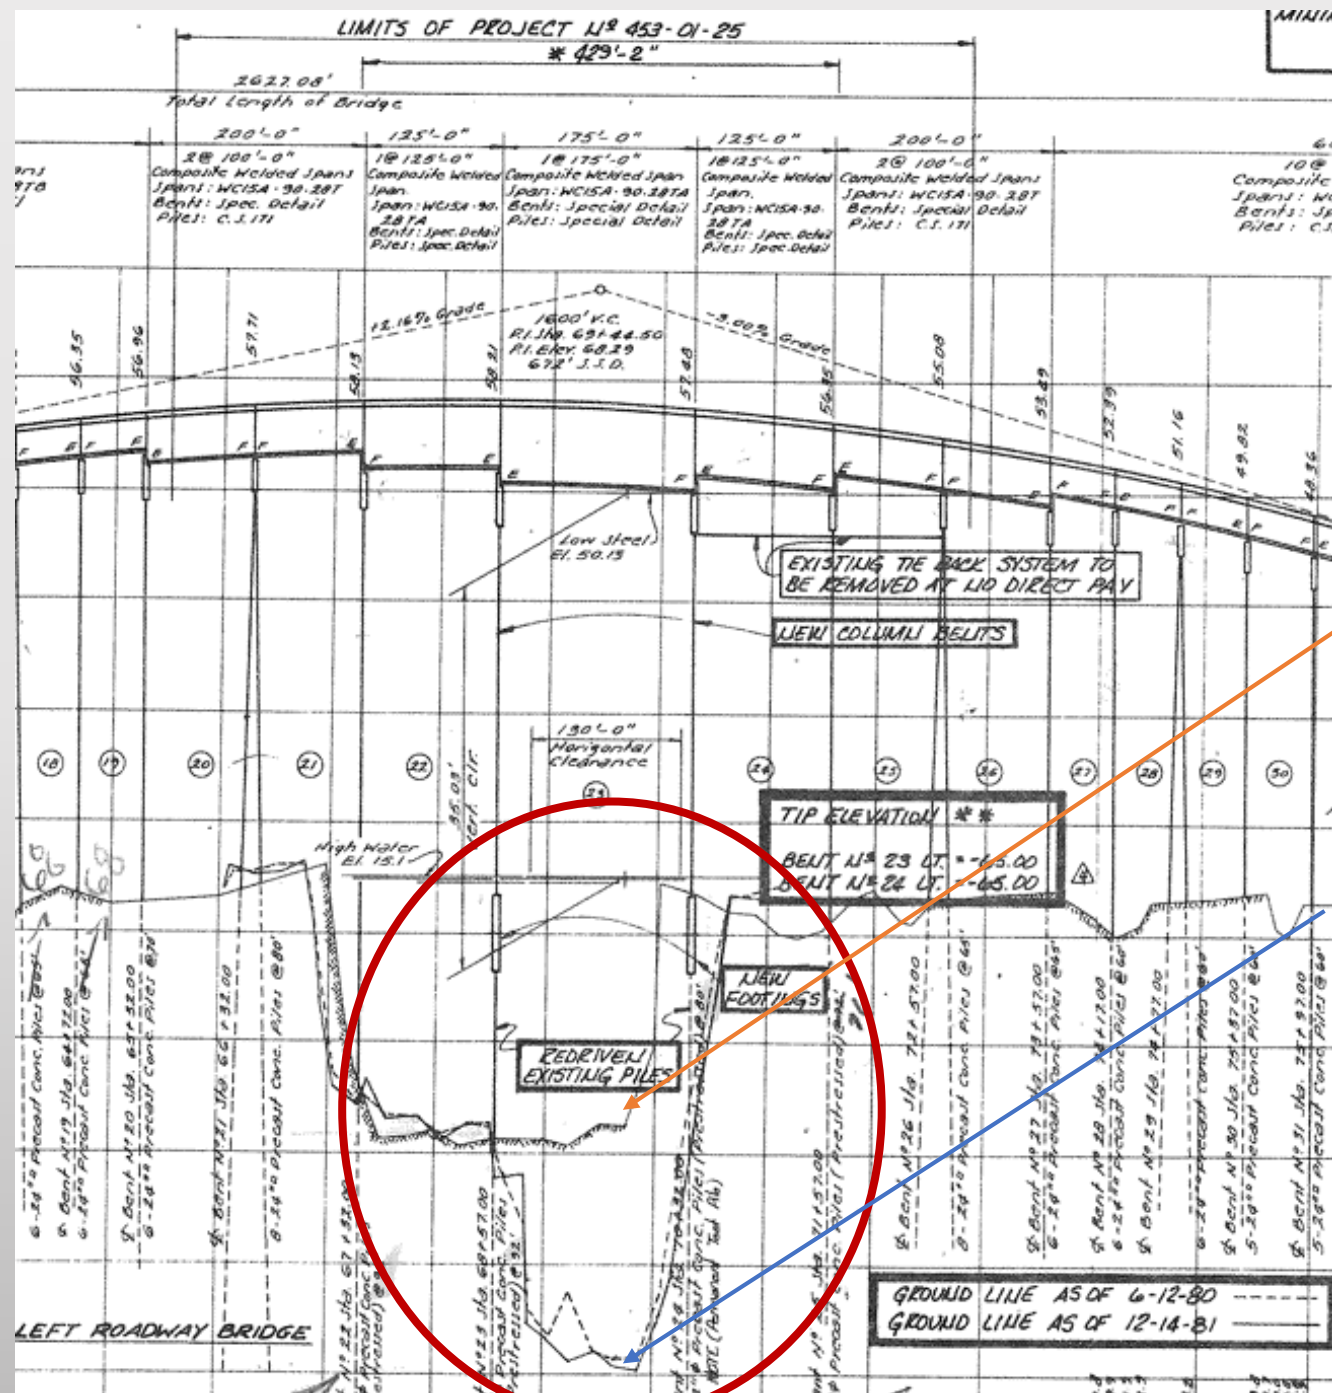
ORIGINAL
GROUND LINE

GROUND LINE
AFTER OBSERVED
SCOUR

1. SCOUR CAUSING HEAVY LOSS OF PILE
PENETRATION AT BENTS 23 AND BENTS 24

2. EXCESSIVE MOVEMENTS AT THEIR TOPS, 3" TO 4"

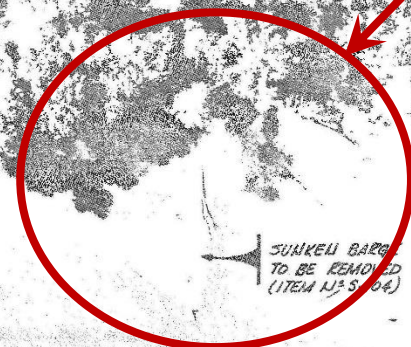
SUNKEN
BARGE

5. It is recommended that our Legal Section take whatever action is necessary to have a sunken barge removed from the channel on the upstream side of the bridge.
