2018 AASHTO SCOBS Bridge Meeting T-1 Bridge Security & Hazards

Case Studies Rehabilitation from extreme events

Artur D'Andrea

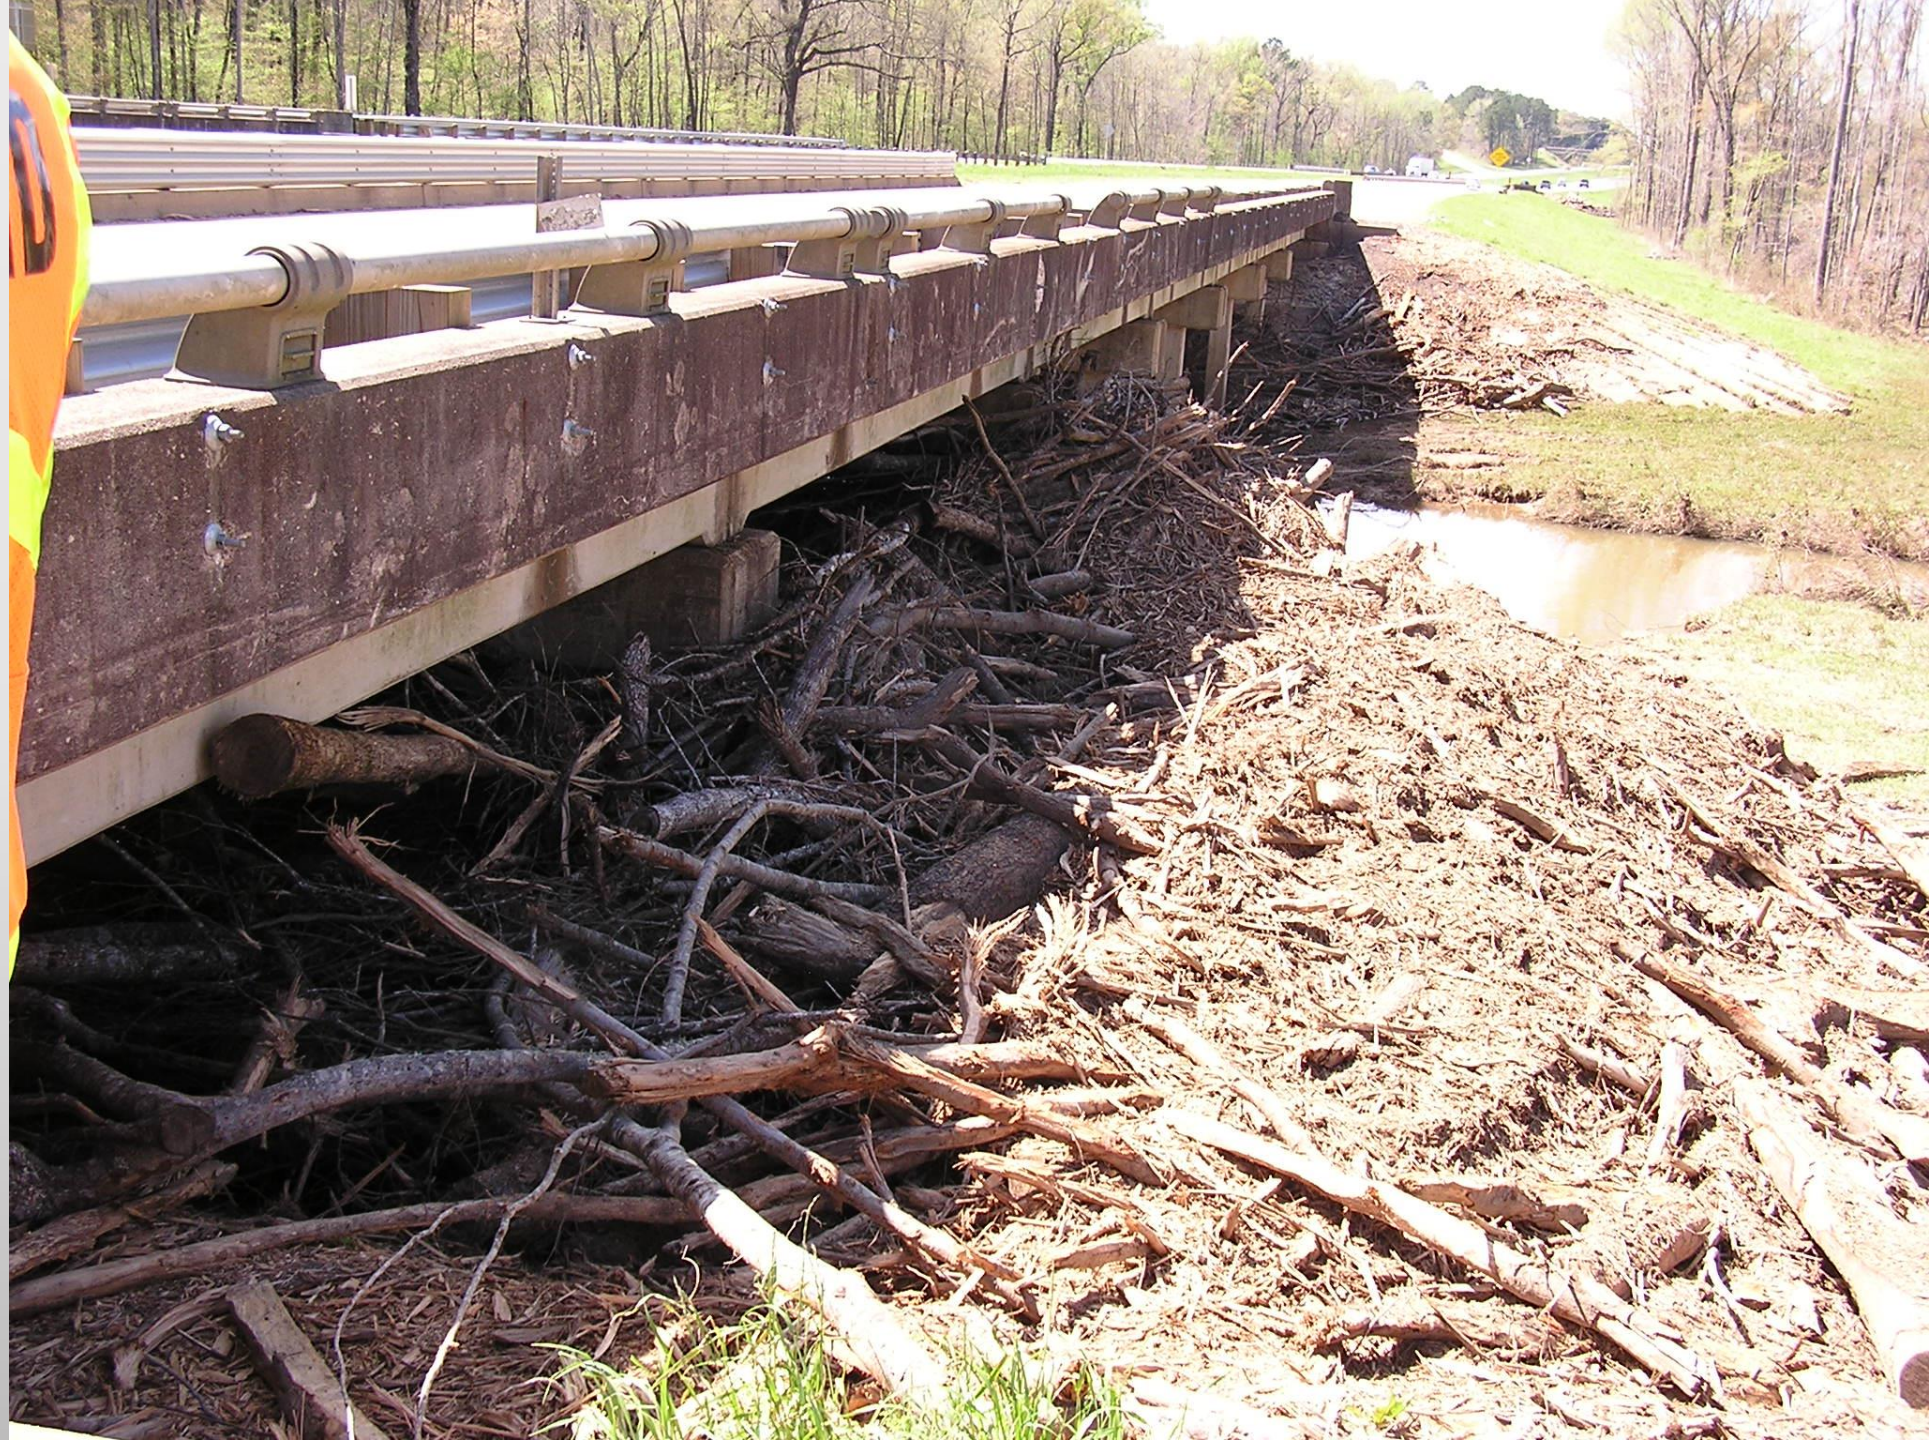
March 2016 Flood

Drift accumulation on northwest corner of bridge. Bridges are adjacent to recent clear cut. Cast-in-place revetment failure and wash out on east end between eastbound and westbound bridges ~ approximately 100 ft x 25 ft.

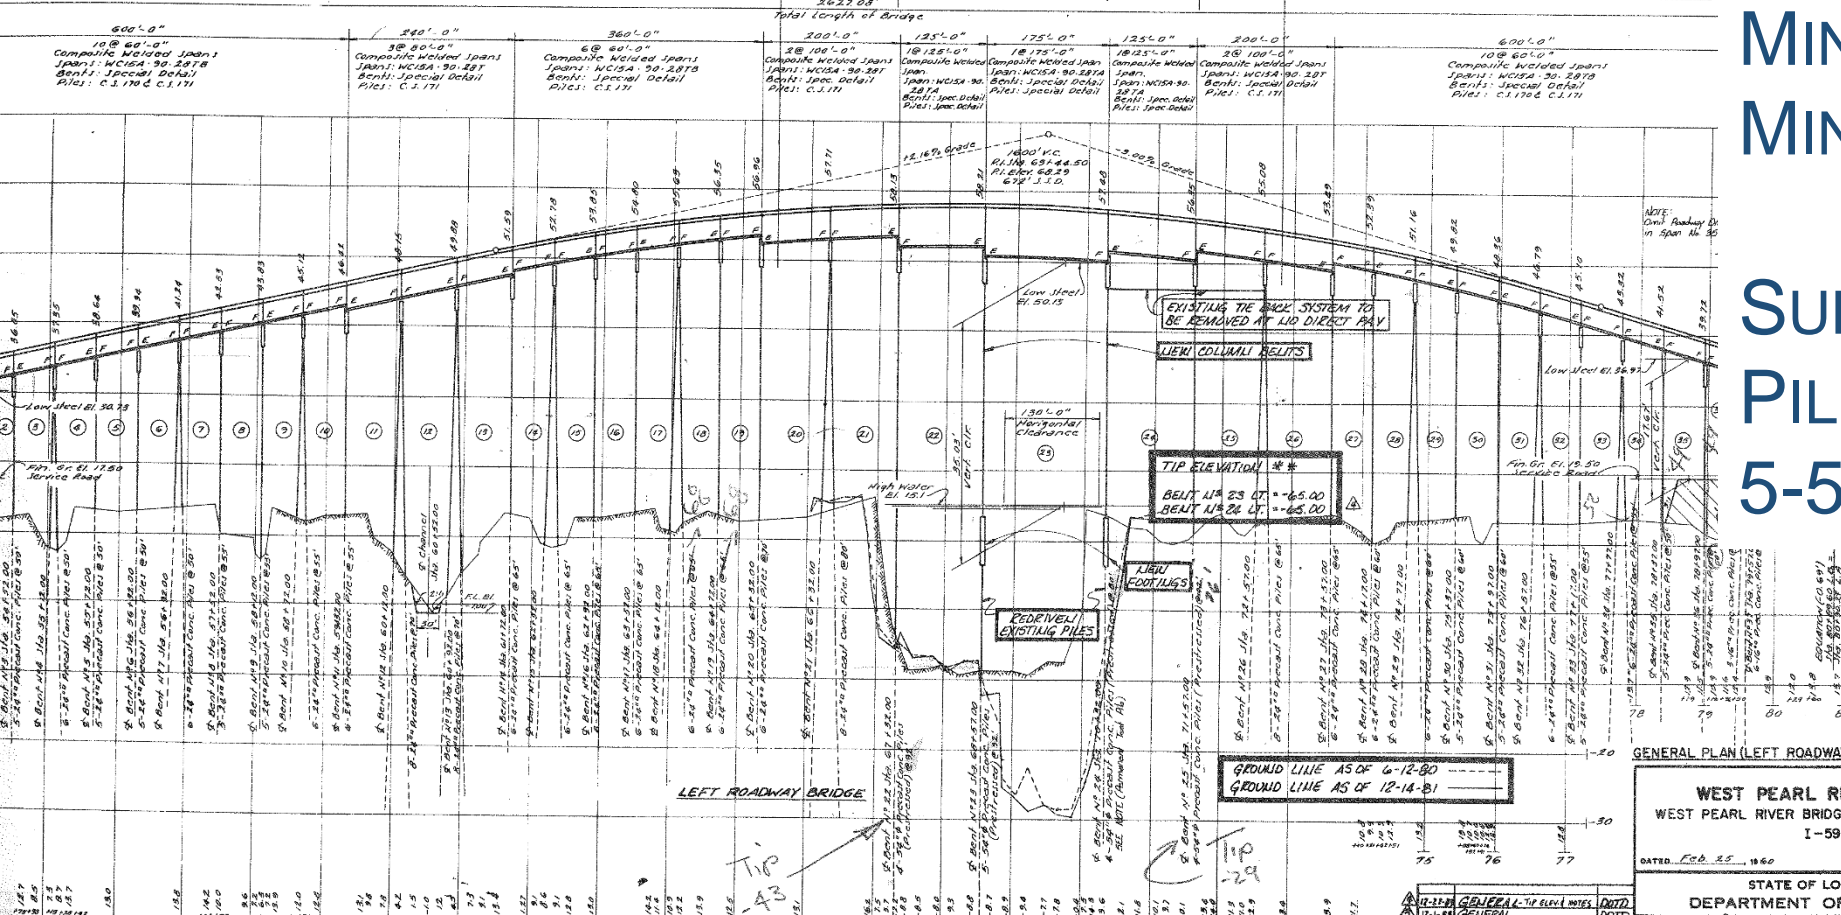
ORIGINAL
GROUND LINE

GROUND LINE
AFTER OBSERVED
SCOUR

1. SCOUR CAUSING HEAVY LOSS OF PILE
PENETRATION AT BENTS 23 AND BENTS 24

2. EXCESSIVE MOVEMENTS AT THEIR TOPS, 3" TO 4"

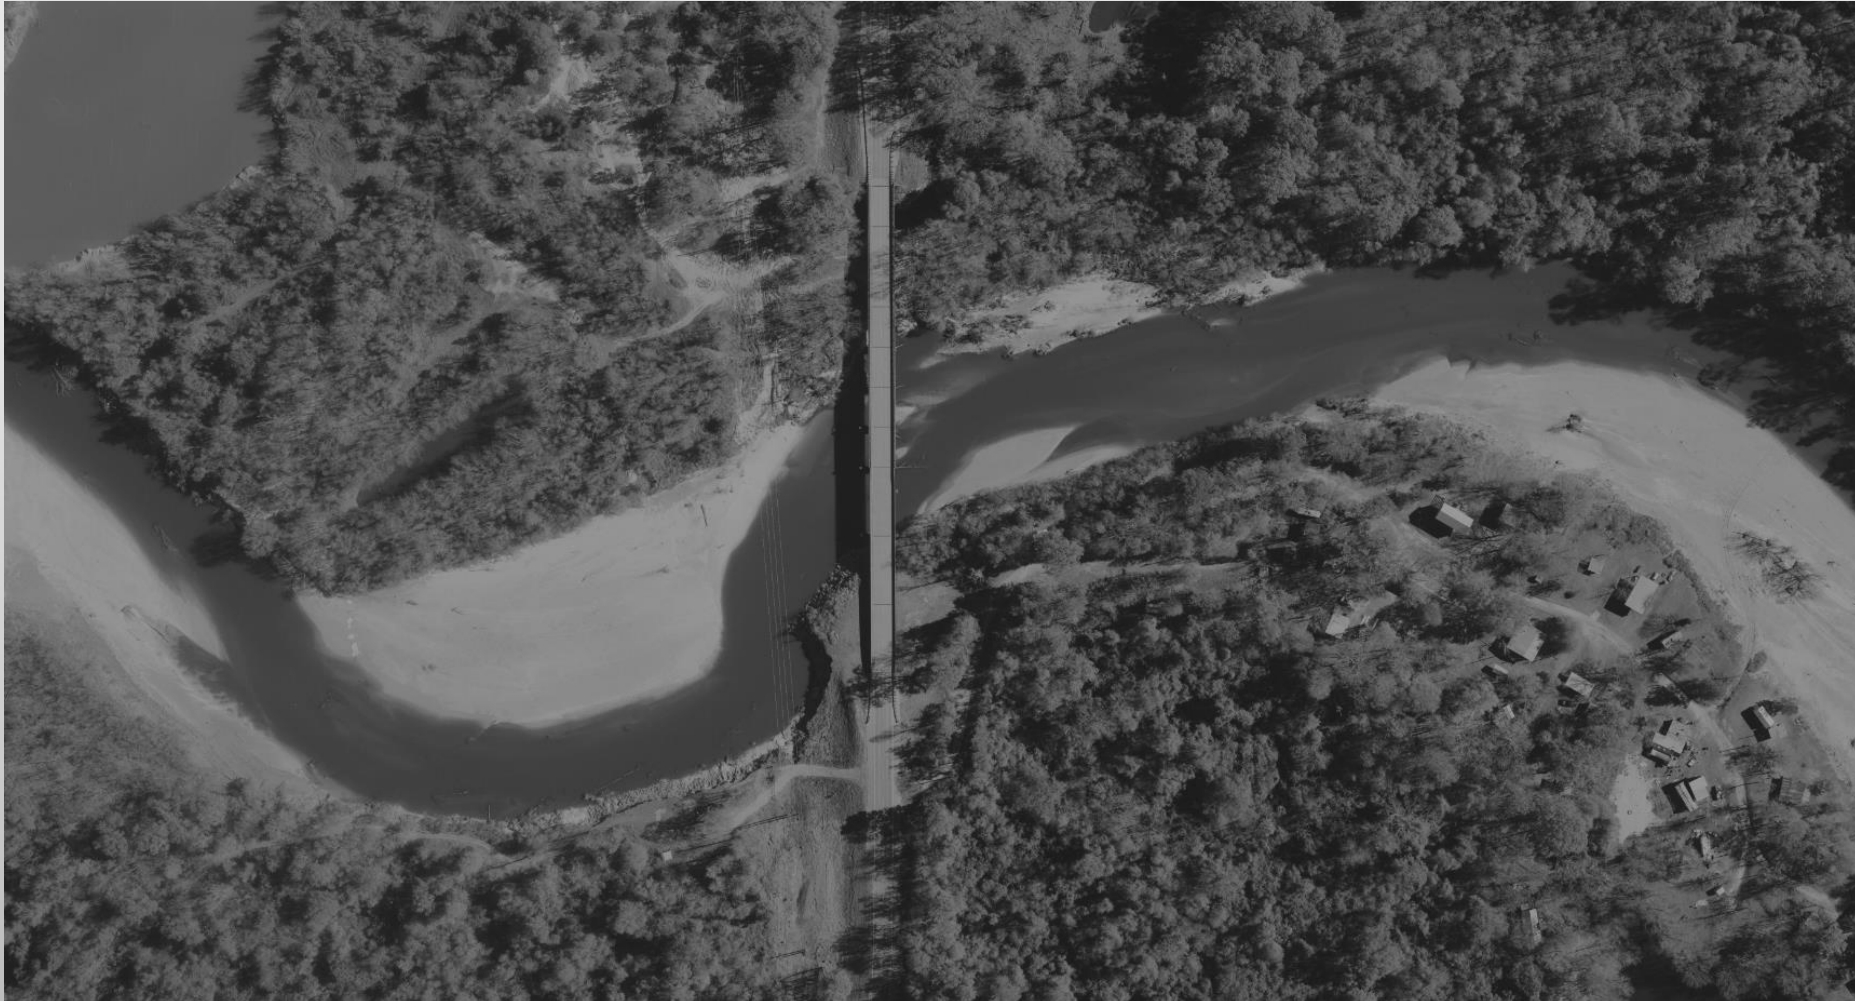
Channel Migration: December 2015 Aerial

Channel Migration
